**VAN HORN PARK UPPER DAM
MA 00574**

**PHASE 1 INSPECTION REPORT
NATIONAL DAM INSPECTION PROGRAM**

JULY 1978

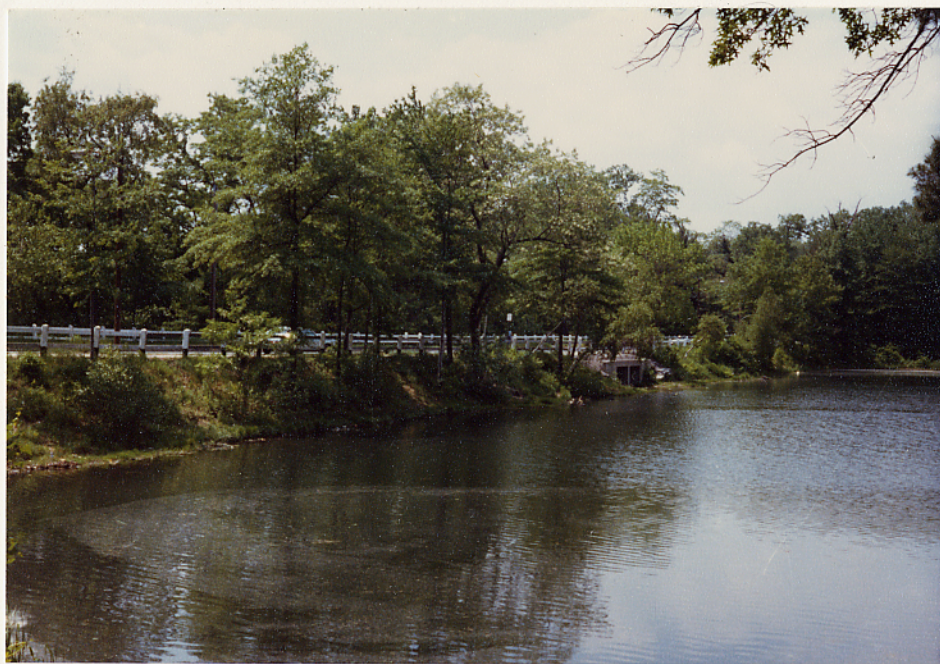
① GENERAL OVERVIEW OF UPSTREAM SLOPE OF DAM AND POND

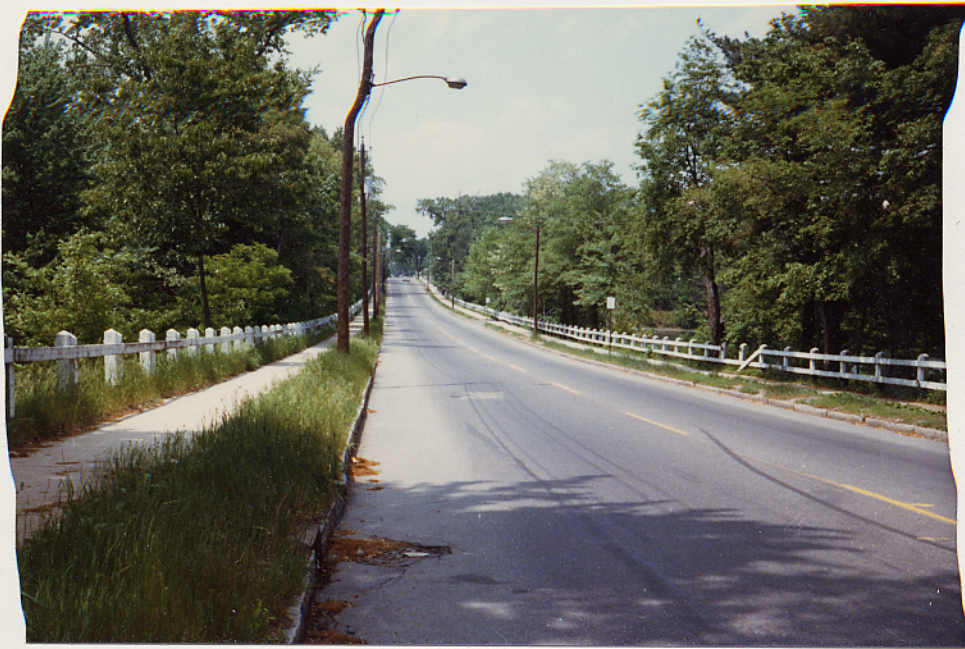
Surface Cracks asphalt pavement on crest shows longitudinal & transverse cracks in region of box culvert. Sidewalk shows evidence of minor vertical displacement

② VIEW OF CREST (ARMORY STREET) LOOKING NORTH

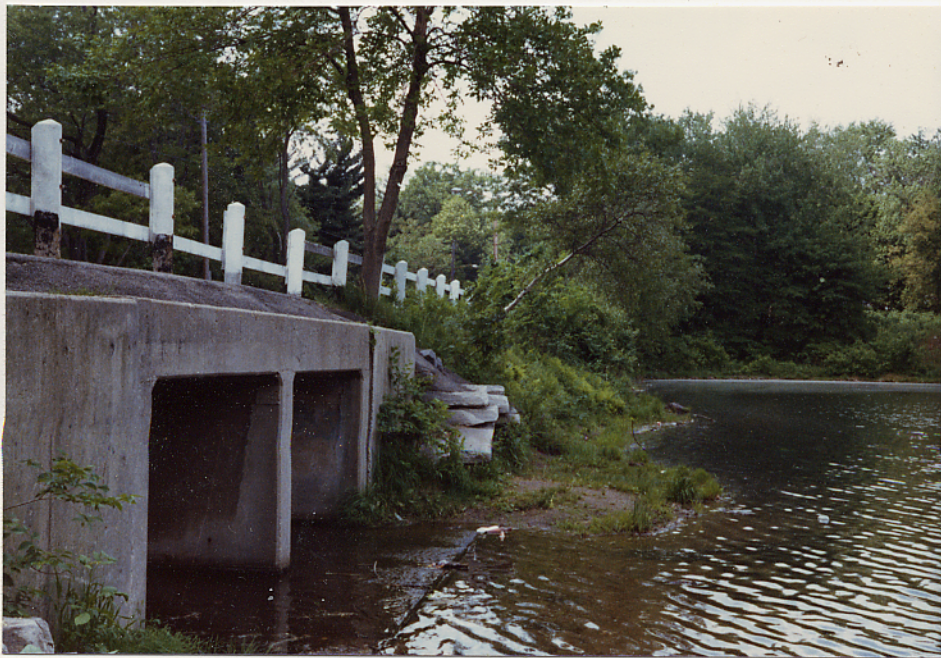
The upstream slope of the embankment shows evidence of some erosion and sloughing as a result of runoff, with some erosion as a result of trespassing. The heavy vegetation makes it impossible to discern whether there are cracks on the slope surface. The downstream slope, shows signs of erosion, sloughing and seepage. The causes of the erosion and sloughing are generally the same as those at the upstream slope.

The reinforced box culvert appears to be in good condition with only little debris in evidence. The upstream culvert headwalls have separated from the culvert and are displaced upstream approximately 2 inches. (See Photograph). Immediately beyond the headwalls there is riprap protection, approximately 10 ft wide, which has been covered with asphalt; it serves as slope protection against erosion by runoff from the paved crest. (See Photograph). On top of the box culvert, 2-1/2 feet from the upstream edge, a metal pipe approximately 12 inch diameter, covered with asphalt, crosses the culvert. The pipe is anchored by means of two U-bolts to the underside of the roof of the culvert.

③ VIEW OF UPSTREAM SLOPE LOOKING NORTH, ENTRANCE TO BOX CULVERTS, RIPRAP PROTECTION, DISPLACED HEADWALL AND HEAVY VEGETATION

- a. Gullys and channels formed on the downstream slope should be filled with suitable compacted embankment material and restored to grade.
- b. Joints between box culvert and headwall, headwall and spillway chute, and between spillway chute sections should be sealed with appropriate joint filler material to prevent any further washing out of foundation materials.

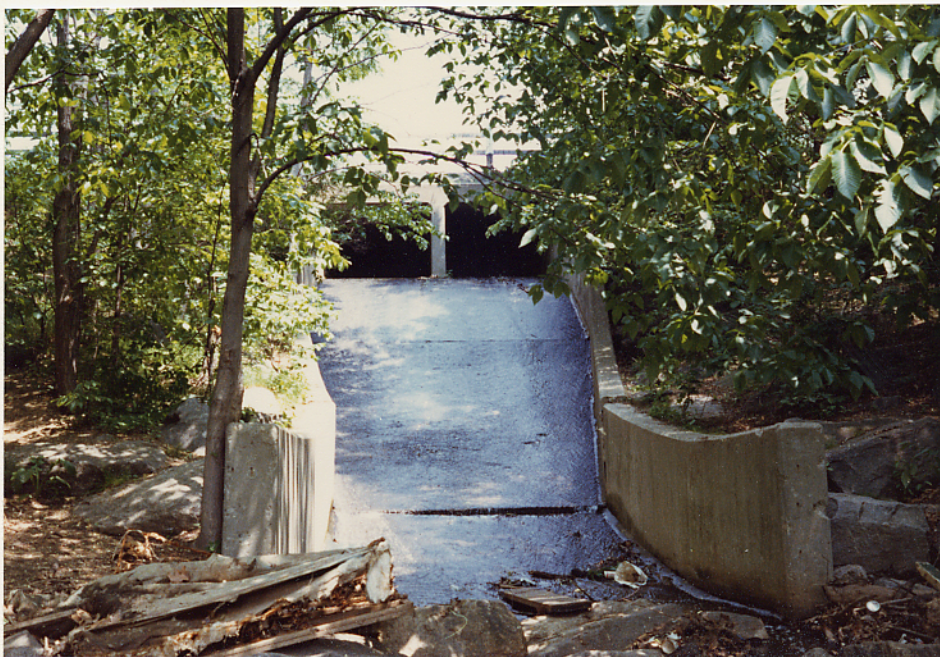
The spillway chute which consists of three reinforced concrete monoliths is in relatively good condition. There is evidence of minor spalling of the concrete surface and erosion at the contact of the walls with the floor. The lower downstream section has settled non-uniformly, approximately 4 inches on the south side and 1 inch on the north side, with an approximate downstream displacement of 2 inches. The upper section has separated from the box culvert about 1/2 inch in downstream direction. Riprap protection which surrounds the spillway chute is covered with vegetation and on the south side, near the culvert head wall, it has undergone approximately 6 inches of settlement. At the downstream end of the chute, the riprap has moved probably by flood flows.

Condition at Joints lower monolith of the chute has settled non-uniformly, 4" on South wall and floor and 1" on North wall and floor with downstream separation of approximately 2". upper monolith of the chute has separated from bed culvert about 1/2" downstream

Condition of Discharge Channel Riprap at the end of the chute have been displaced towards the pond. Partial blockage with debris.

④ SPILLWAY CHUTE, SHOWING DISPLACEMENT OF LOWER SECTION,
DISPLACEMENT OF RIPRAP, DEBRIS AND HEAVY VEGETATION

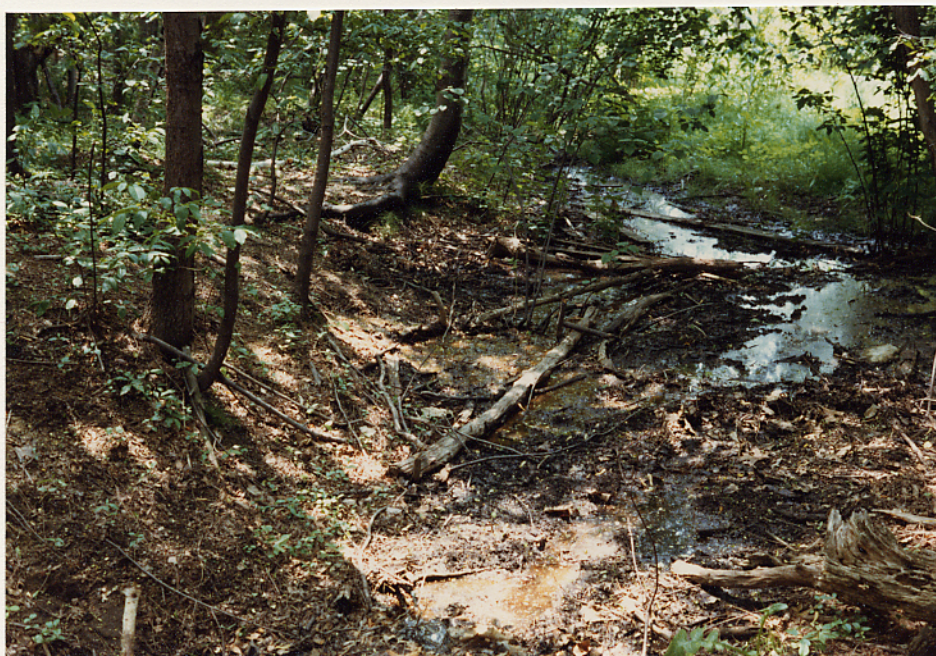
There are two areas of seepage, one located approximately 45 feet south of the spillway chute and covers an area of approximately 300 square feet. In the center of this area, at approximately the toe of the slope at El. 143± a rivulet is flowing at the rate of approximately 5 gpm. It appears that this condition has existed for some time since it was noted in a previous inspection report prepared by the Commonwealth. In the area of seepage there are signs of limonitic staining and algae growth (See Photograph). A second rivulet, at approximately the same elevation, is located in a gully eighty feet south of the spillway chute. The gully has been formed by storm water flowing from a 12 inch diameter concrete bell and spigot drain pipe attached to a roadway catch basin. The gully starts about 20 feet downstream from the edge of the crest and is about 3 feet deep until it reaches the toe. (See Photograph).

⑤ SEEPAGE AREA IN GULLY FORMED BY FLOW FROM CATCH
BASIN DRAIN LOCATED ON CREST LOOKING DOWNSTREAM

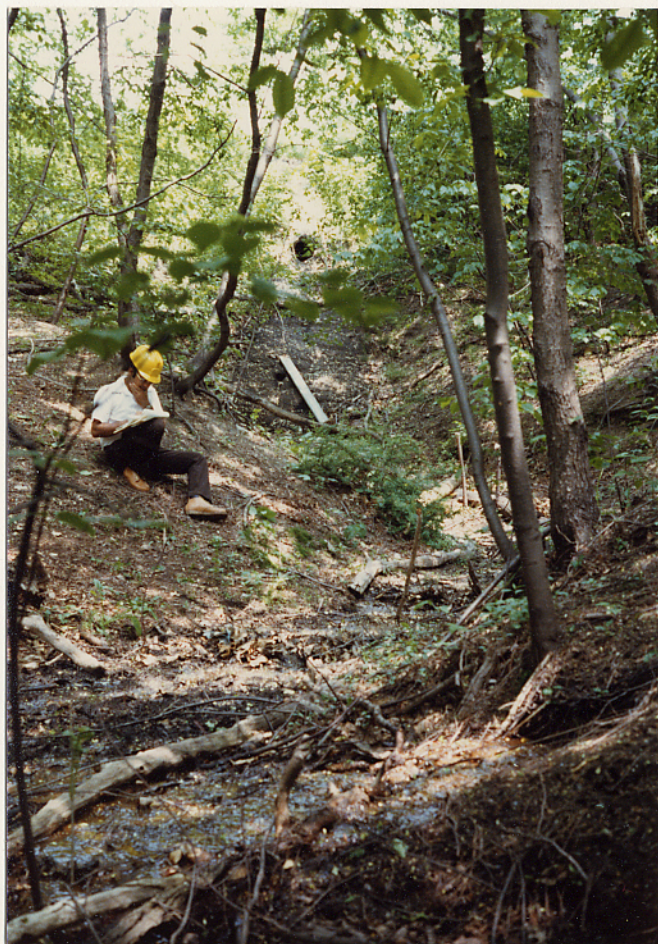
⑥ SEEPAGE AREA IN GULLY FORMED BY FLOW
FROM CATCH BASIN DRAIN LOCATED ON CREST
LOOKING UPSTREAM

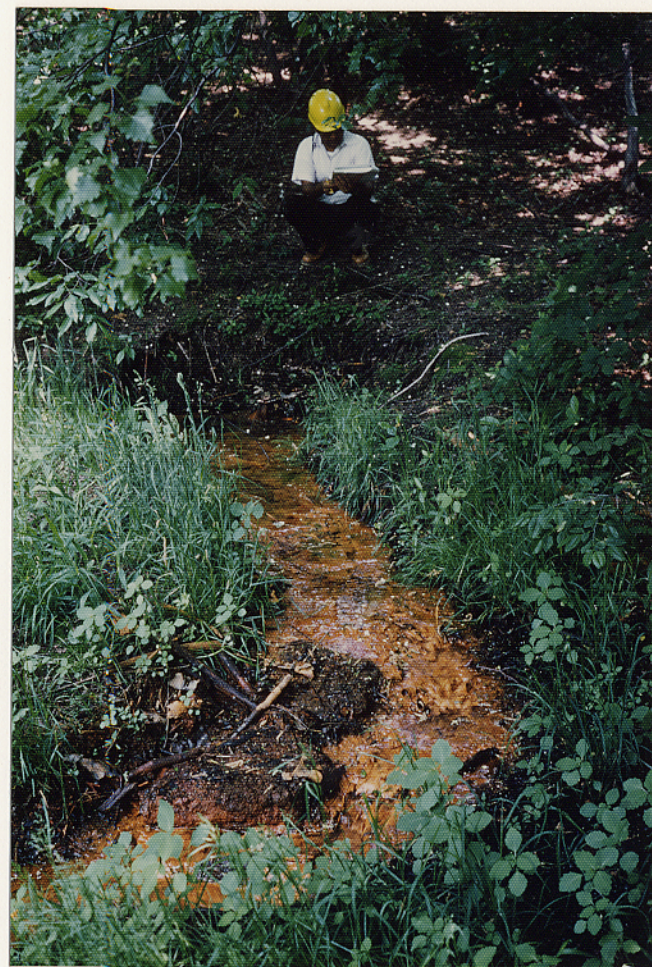
⑦ SEEPAGE AREA - NOTE LIMONITIC STAINING

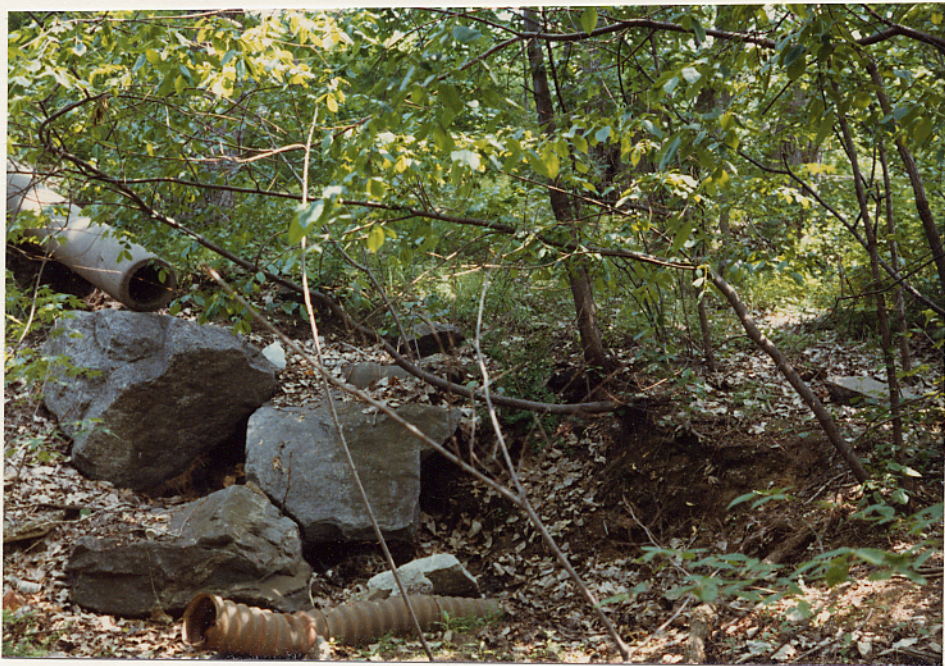
⑧ POTHOLE ERODED BY FLOW FROM CATCH BASIN LOCATED ON CREST
